The Deer Creek Watershed Restoration Plan

March 2011

Written by: Friends of Deer Creek/Sierra Streams Institute and The Tsi-Akim Maidu

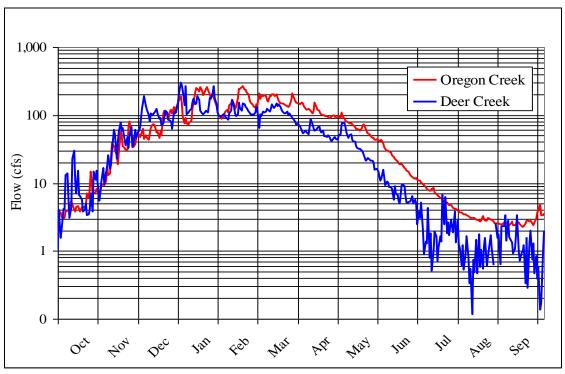
Figure 4.10: Average Daily Flows in Deer Creek (into Scotts Flat) and in Oregon Creek at Camptonville (USGS gauge #11409300, 1967-2001)

Oregon Creek, a tributary to the Middle Yuba River, is similar to the upper, higher elevation portions of the Deer Creek watershed in many respects (e.g. size, shape, orientation, elevation and vegetation). USGS gauge #11409300 captures 23 mi² of the Oregon Creek watershed, similar to the 22 mi² area upstream of Scotts Flat Reservoir. With many characteristics similar to the upper portions of Deer Creek, Oregon Creek serves as a useful proxy for estimating low flows in the upper quarter of the Deer Creek watershed under natural conditions. One can see that the flows are fairly similar in magnitude and timing, with Oregon Creek exhibiting slightly higher flows from February through September (**Figure 4.10**). Deer Creek appears to experience lower and more variable summer low flows, but NID's method of estimating Deer Creek inflows is less accurate at lower flow levels, and there are more rise and fall changes due to NID water management, which leads to a less smooth hydrograph than Oregon Creek.

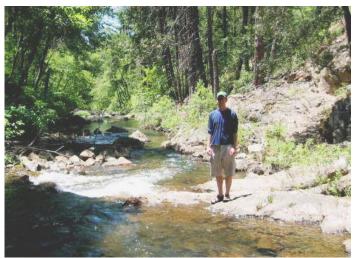
Figure 5.10: Bedrock Outcropping Below Scotts Flat

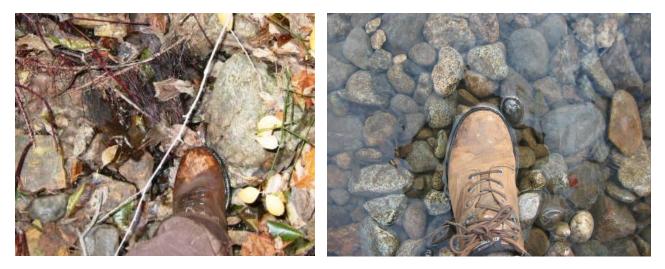
Figure 5.11: Substrate Immediately Below Scotts Flat (L), and 3 miles Downstream I

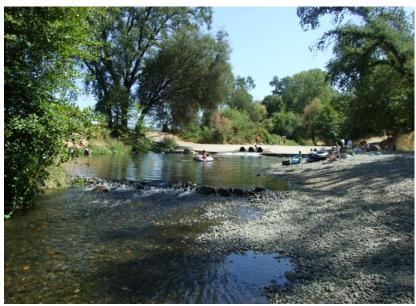
- 13. Indentify historic creek channels and potential for restoration actions.
- 14. Clean up contaminated mine tailings and other pollutants.
- 15. Replace native animal and plant species missing from the habitat.

Figure 6.25 further illustrates the potential health risk associated with recreational activity in Squirrel Creek as site 15 *E. coli* concentrations in the summer exceed the single sample maximum standard in over 60% of the samples collected. The high frequency of exceeding the single sample standard suggests that with more frequent sampling, the geometric mean standard would also be exceeded. At site 15, residents of a local mobile home park make up the majority of recreational users; however a popular public swimming hole located in Western Gateway Park, Penn Valley (**Figure 6.26**) is only 0.85 miles downstream of this site.

In order to determine if elevated *E. coli* concentrations are also present at Western Gateway Park, extensive sampling was conducted at the swimming hole during the 2008 and 2009 recreation seasons. This included collaborative sampling with the Central Valley Regional Water Quality Control Board (CVRWQCB) and the Nevada County Environmental Health Department (NCEHD). In 2009 FODC/SSI conducted bacteria sampling to capture the geometric mean, which is required to determine if the USEPA and CVRWQCB geometric mean standard is being exceeded. Results for the 2009 geometric mean sampling at Western Gateway Park are included in the appendix (**Figure 6A.10**).

E. coli concentration results at the outlet of the Western Gateway Park swimming hole during 2008 indicate that high *E. coli* concentrations found at site 15 (0.85 miles upstream of Western Gateway Park) persist downstream at the swimming hole in the park (**Figure 6.27**). The results indicate that 33% of the samples from Western Gateway Park exceeded the single sample maximum standard for *E. coli*, compared to approximately 66% at site 15, with over 85% of the sample concentrations exceeding the geometric mean standard. Samples collected at the end of August and early September were a part of a CVRWQCB "Safe-to-Swim" study.
